EUROPEAN PATENT APPLICATION

(54) Member for indicating clogging of the air intake filter, particularly for motor vehicle engines.

EP 0 200 688 A1

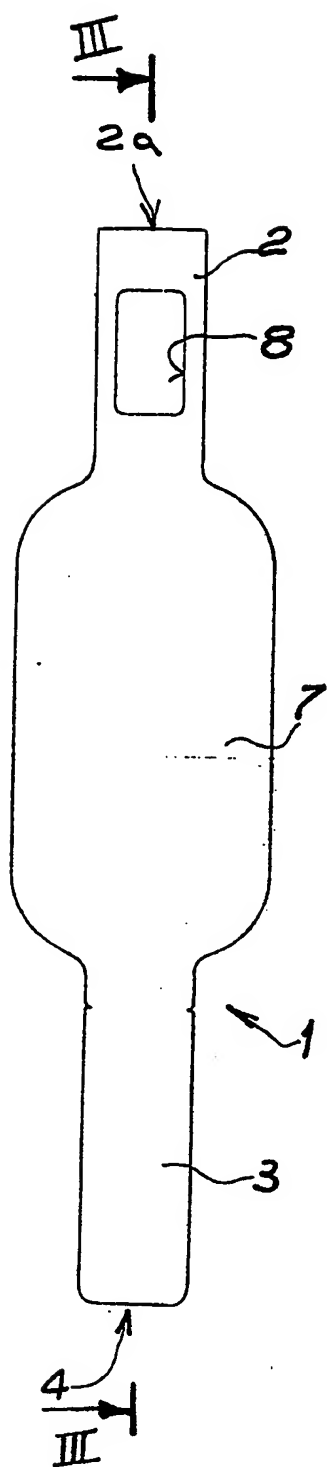
Fig. 1

Figure 1 is a plan view of the indicator member according to the
20 invention;

As can be seen from the figures, the indicator member according to the
30 invention consists of a duct 1 having an end portion 2 provided with an opening 2a to be located in communication with a zone external to the filter, and a tubular end portion 3 provided with an opening 4 communicating with the zone in which the air leaves the filter towards

A thin strip 6 of plastics material or the like is connected to this piston and extends through the intermediate portion 7 of the duct 1 as 10 far as the end portion 2. In proximity to the opening 2a of said end there is an aperture 8, through which the end part of the strip 6 can be seen.

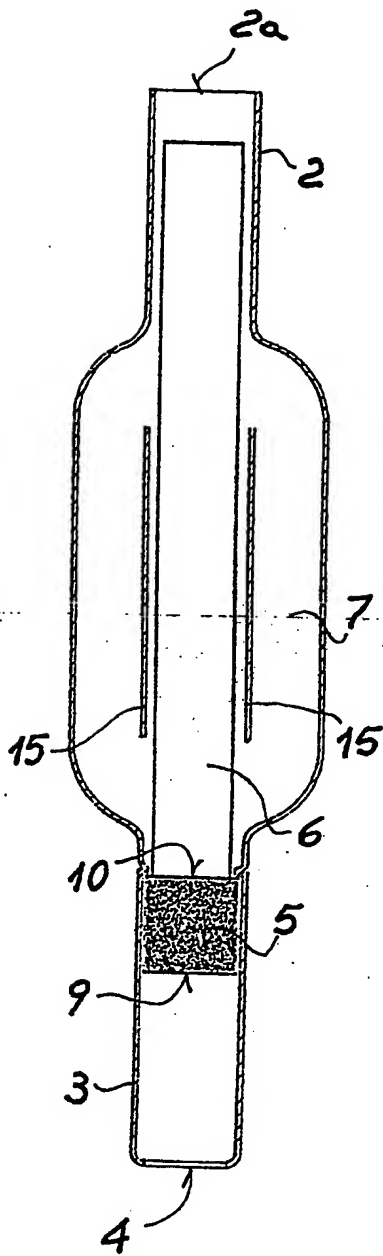
Fig. 2

Figure 2 shows the indicator member of Figure 1 without its upper part;

In the tubular end portion 3 there is disposed a piston 5 of light material such as expanded closed-cell material, which can slide within 5 the tubular portion 3 under the action of a slight pressure difference between the two parts of the tubular portion 3 separated by it.

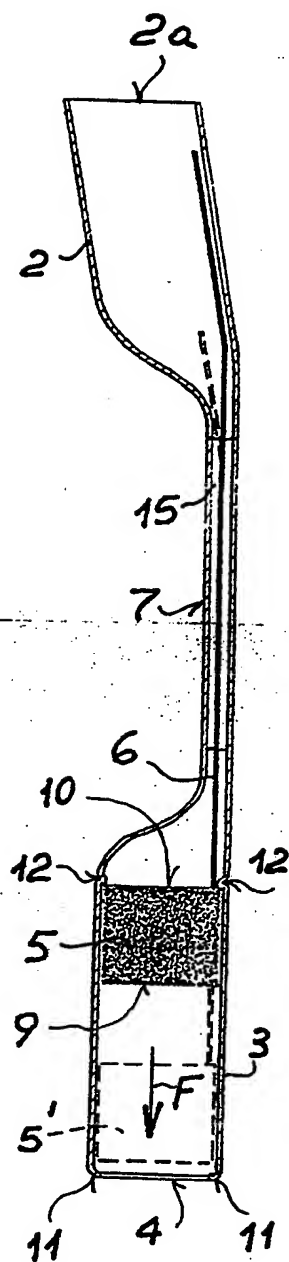
Fig. 3

Figure 3 is a section on the plane III-III of Figure 1; and

When the filter is clogged, the air drawn in by the engine undergoes a 20 large pressure drop in passing through the filter, and this results in a vacuum at the filter outlet in the direction of the engine. This vacuum also acts on the face 9 of the piston 5 which faces the end portion 3, whereas the pressure of the external environment acts on that face 10 of the piston which is in communication with the outside by way of the 25 intermediate portion 7 and the end portion 2 of the duct 1. Under these conditions, the piston thus moves in the direction indicated by the arrow F of Figure 3 to the position indicated by 5', in contact with the rim 11 at the opening 4 of the tubular end portion 3. The strip 6 is therefore no longer visible through the aperture 8, and this therefore 30 signals that the filter is clogged and requires replacement or cleaning.

When the filter has been replaced or cleaned, the piston 5 can be again moved into its initial position, indicated by the stop projections 12

provided internally on the end portion 3 in the position in which the end of the strip 6 is visible through the aperture 8.

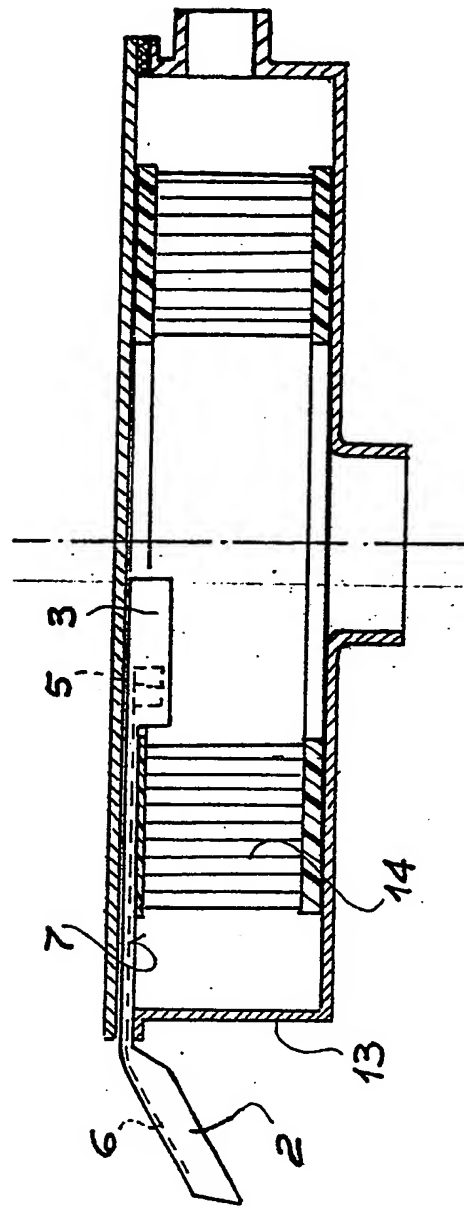
Fig. 4

Figure 4 is a diagrammatic section through a filter provided with the indicator member according to the invention.

As can be seen in Figure 4, the indicator member according to the invention can be mounted in a filter casing 13, and disposed with its intermediate portion 7 over the annular filter 14. The tubular portion 3 thus lies in the inner zone of the filter, in communication with the engine intake duct, and the end portion 2 lies external to the casing 13, enabling the aperture 8 to be seen without dismantling the filter casing.

This is attained by a slight deformation of the seal gaskets of the casing 13 and filter 14, the intermediate portion 7 being constructed with a very small thickness, which is less than the deformability of said gaskets.

The intermediate portion 7 is wider than the remaining parts of the duct 1, to provide in the zone corresponding with said small thickness an intake air passage area large enough to give sufficient indication sensitivity by limiting the pressure drop.

Guide baffles 15 are conveniently provided in the intermediate portion 7 to help maintain the strip 6 aligned with the piston 5 connected to it, and to also provide rigidity to the portion 7 zone which is to be compressed for deforming said gaskets.
